AL KASIK WATER STORAGE TANKS
AL KASIK MILITARY TRAINING BASE
AL KASIK, IRAQ

SIGIR PA-06-071
JANUARY 08, 2007

SUBJECT: Report on Project Assessment of the Al Kasik Water Storage Tanks, Al Kasik
Military Training Base, Al Kasik, Iraq (Report Number SIGIR-PA-06-071)

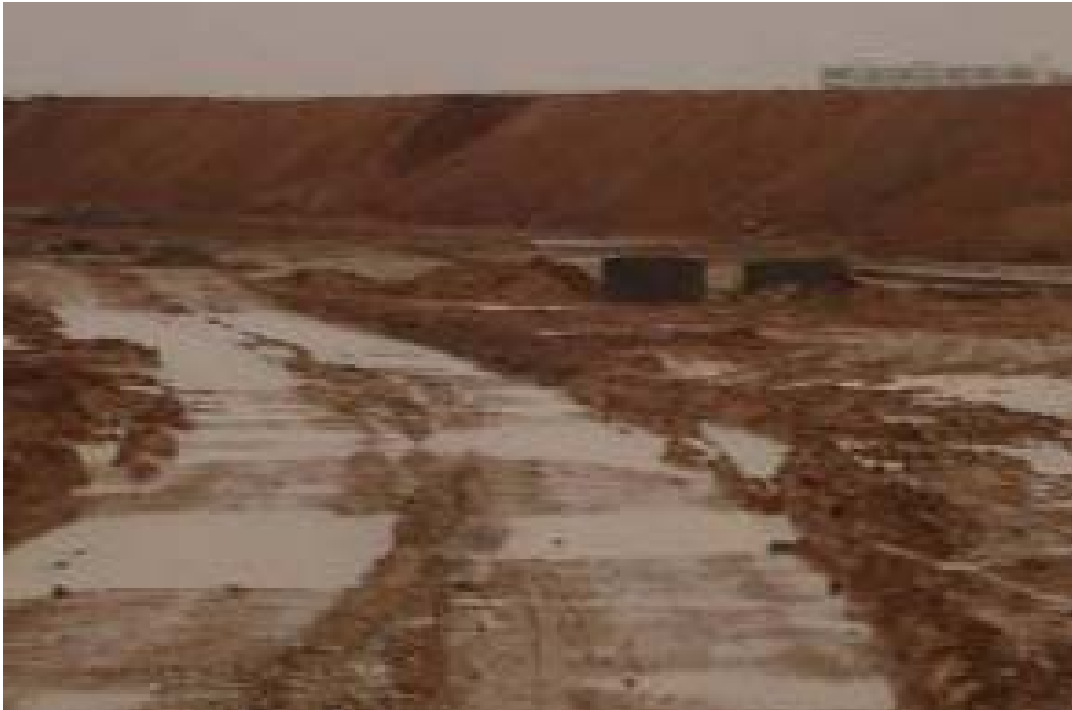
At the time of the assessment team's site visit, the project was reported as 57% complete by the AFCEE/VIAP¹ Quality Assurance Representative (QAR). Although the TO's Field Period of Performance (POP) had been extended to 19 September 2006, the contractor's construction manager stated that the WST project would likely not be completed by then. QA reports confirmed that substantial rain in January, February, and March 2006 contributed to delayed WST project progress (Site Photo 1). In addition, the contractor's construction manager stated that there had been unspecified delays attributable to equipment and material unavailability. At the time of the assessment team's site visit, the sub-contractor was waiting for a sand blaster needed to clean all steel before a protective/finish coating (epoxy paint) could be applied. In addition, the contractor's construction manager stated that a shortage of welders skilled enough to pass a welding test administered by the contractor's QC manager had been a persistent problem.

**Site Photo 1. WST site conditions following overnight rain.
(Photo from QA Report dated 3 Feb. 2006)**

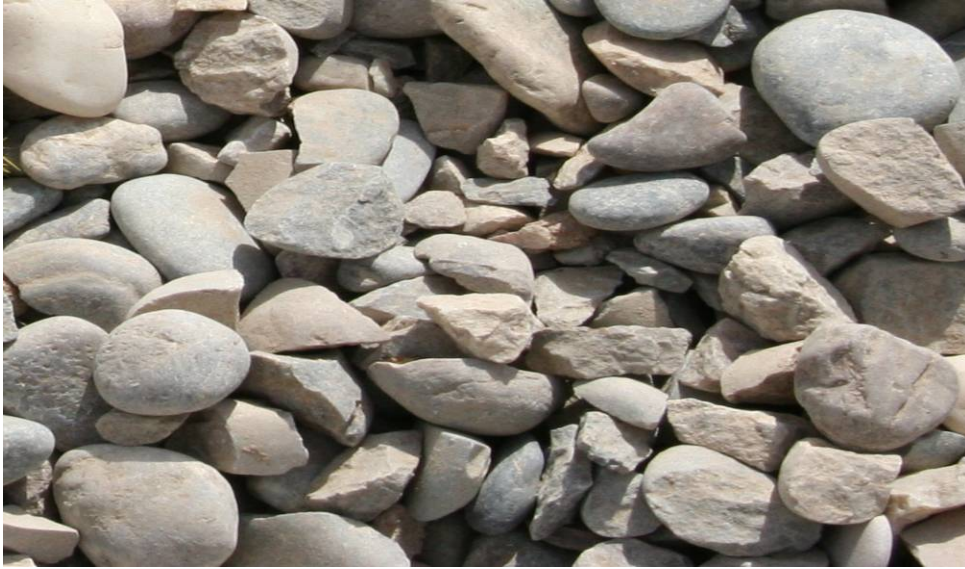
Tank foundation construction started with a concrete foundation, shown in Site Photos 3 and 4. Crushed course aggregate shown in Site Photo 5 was used for on-site production of foundation concrete. To conform to design standards, on-site concrete mixing included the aggregate in a prescribed combination with cement and water. The course aggregate used varied in size from small stone to larger stone, up to approximately 30 mm in diameter. In addition, the crushing process created aggregate with rough asymmetrical surfaces to facilitate effective binding in the concrete when combined with proper amounts of cement and water. We reviewed laboratory tests and confirmed that the concrete met or exceeded strength standards.

Site Photo 5. Crush aggregate used in concrete mix for tank foundation.

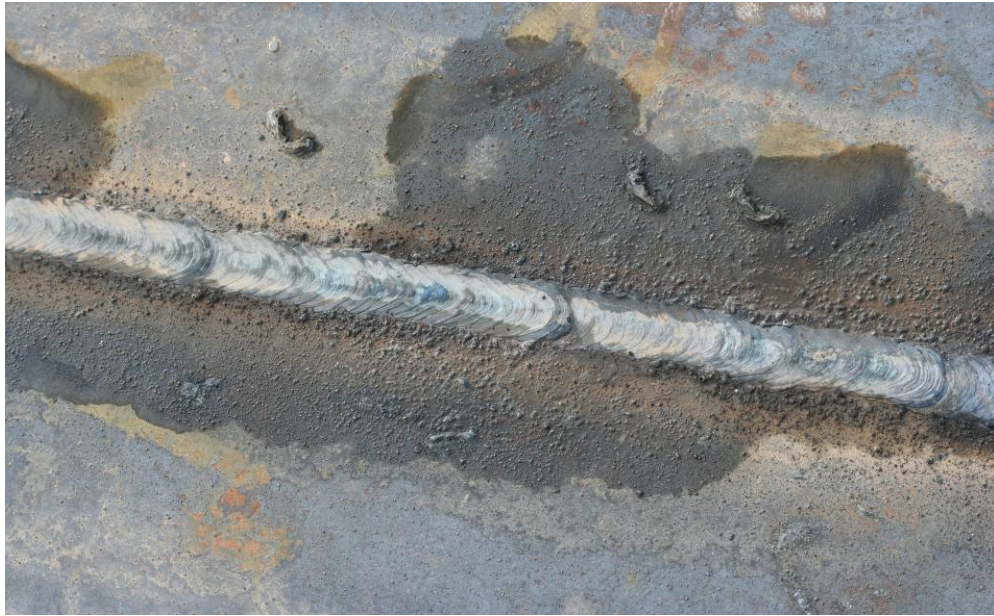
Site Photo 9 displays a successful annular plate weld that passed the vacuum test. Visual inspection by the QC manager pointed out that the uniform thickness, adequate penetration, and uniform rounded swirls of the bead indicated a good weld.

Site Photo 9. High quality annular plate weld.

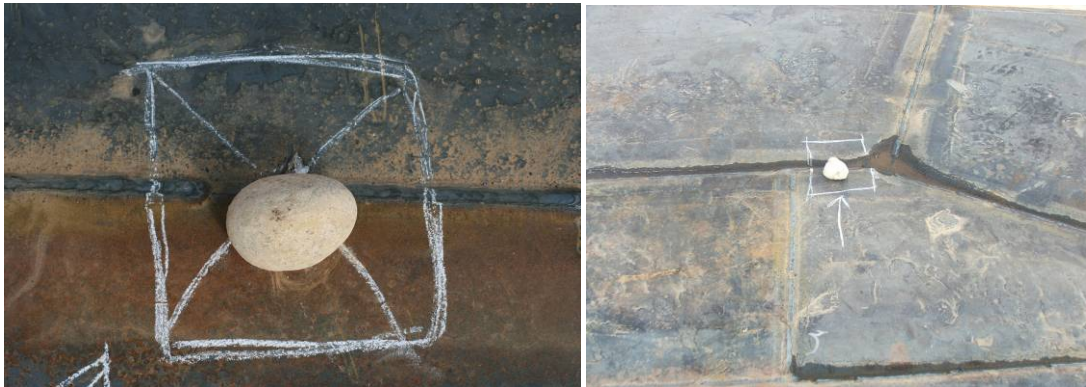
Site Photos 10 and 11. Stones and chalk mark leaks in the steel plating.

Accordingly, all welds that leaked were scheduled for repair and retested in compliance with the contractor's welding procedures. All leaks were marked with chalk and stones to ensure that leaks were located and properly repaired before retesting. Site Photos 10 and 11 show stones and chalk used to mark leaks in the steel plating.

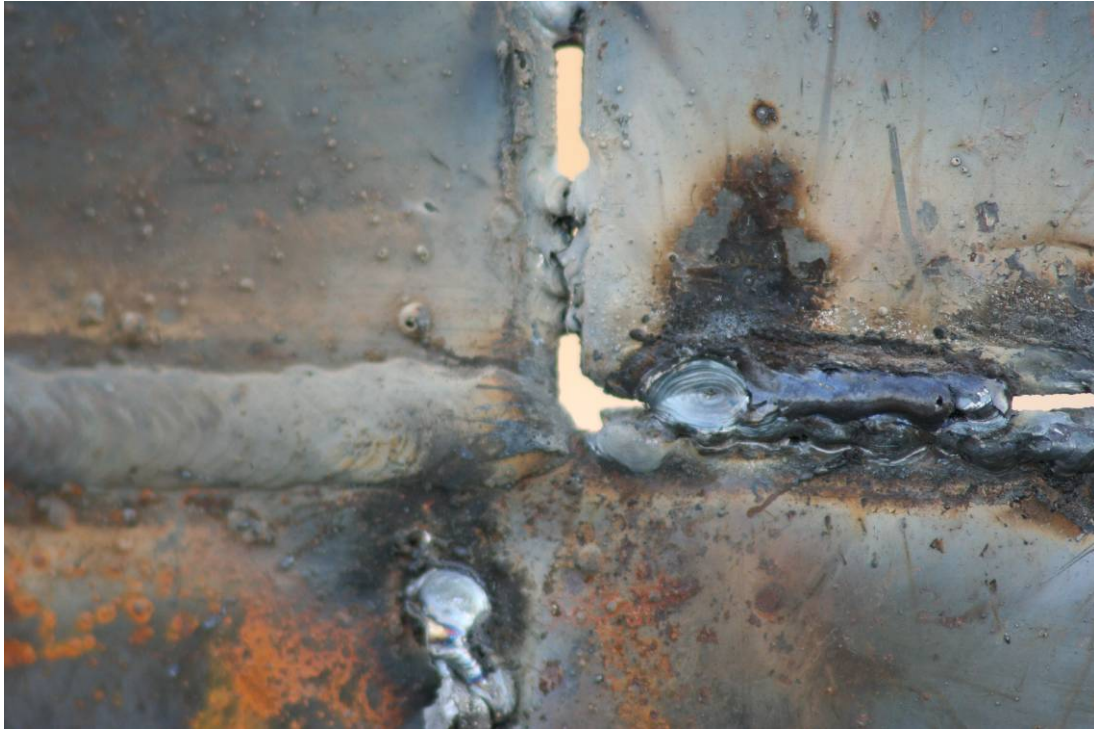
In order to anchor the sheets to the base and fasten adjacent sections, tack welds were utilized. Site Photo 13 shows tack welds along the base of the tank while Site Photo 14 shows the initial fastening of adjacent steel section of wall plating.

Site Photo 14. Tack welds temporarily attach wall plates together.

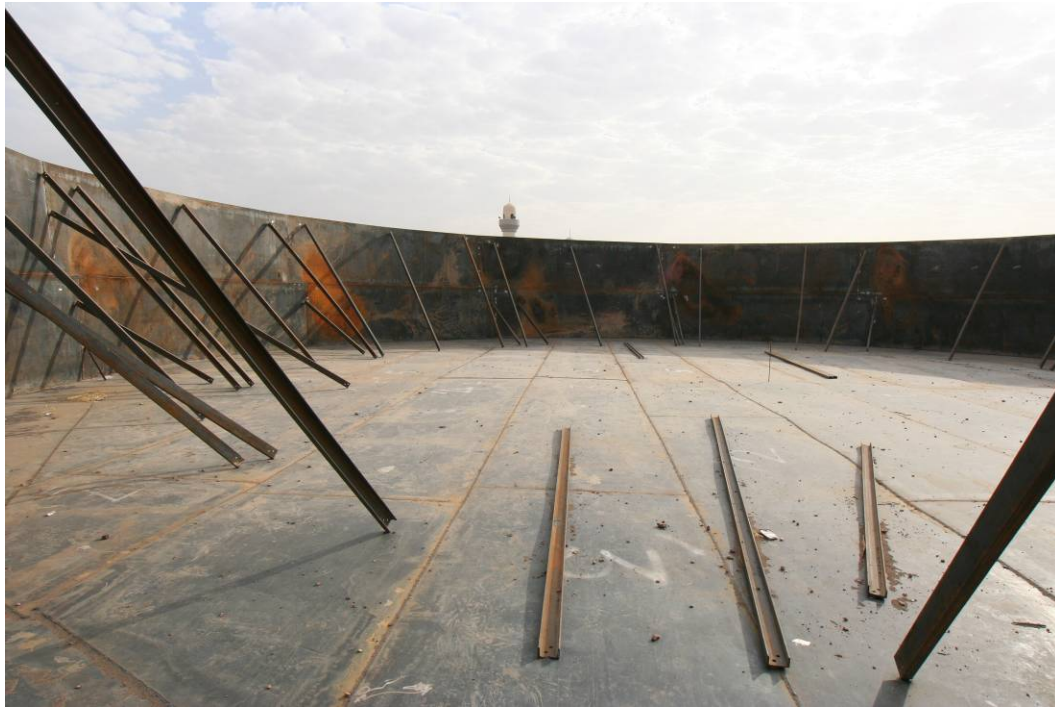
Steel braces were tack welded to the annular plate along with the steel plate walls in order to bear the horizontal forces on the steel shell plates. The steel braces supported the shell plate's transverse load for the placement of welds along

unwelded sections of the steel sheets. An example of the internal bracing supporting the tank wall sections is shown in Site Photo 17.

Site Photo 17. Inner tank bracing supports the attached steel shell plates.

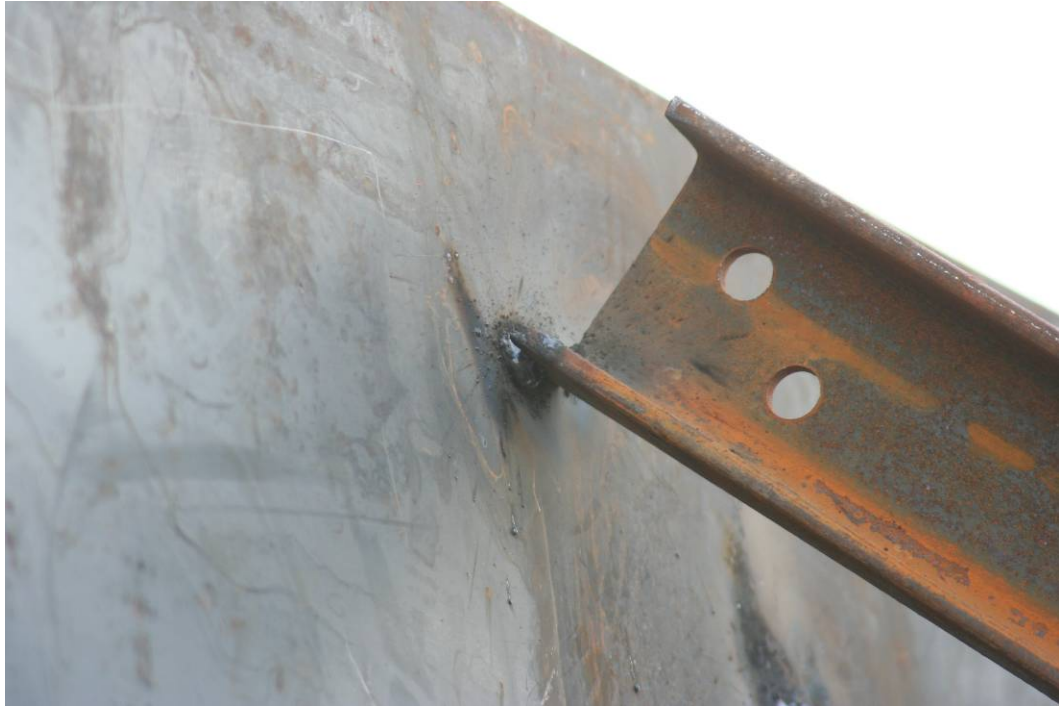
The contact edges of the steel beams were tack welded to the adjacent plates. Site Photos 18 and 19 show the top and bottom tack welds used to attach the steel supports to the tank base and walls. Vertical and horizontal runs (welded seams) were required to attach the plates that make-up the tank's walls. Supporting steel beams were removed once support was no longer needed and welds were secure.

Site Photo 18. Top ends of steel beams are tack welded to the wall plates.

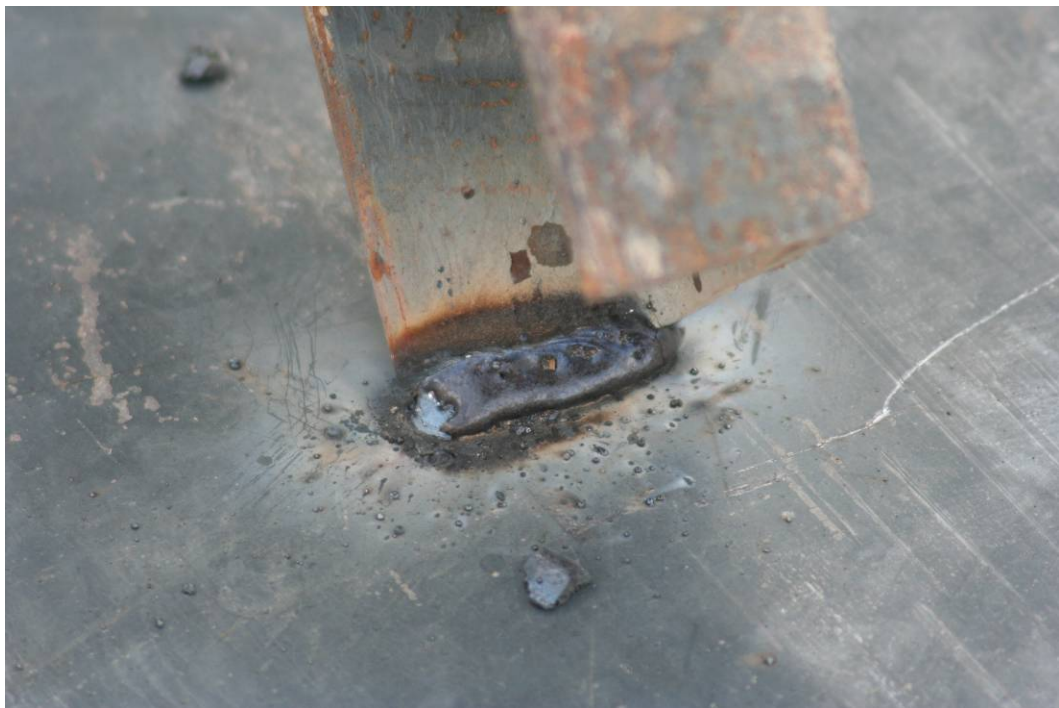
Site Photo 19. Bottom ends of steel beams are tack welded to the floor plates.

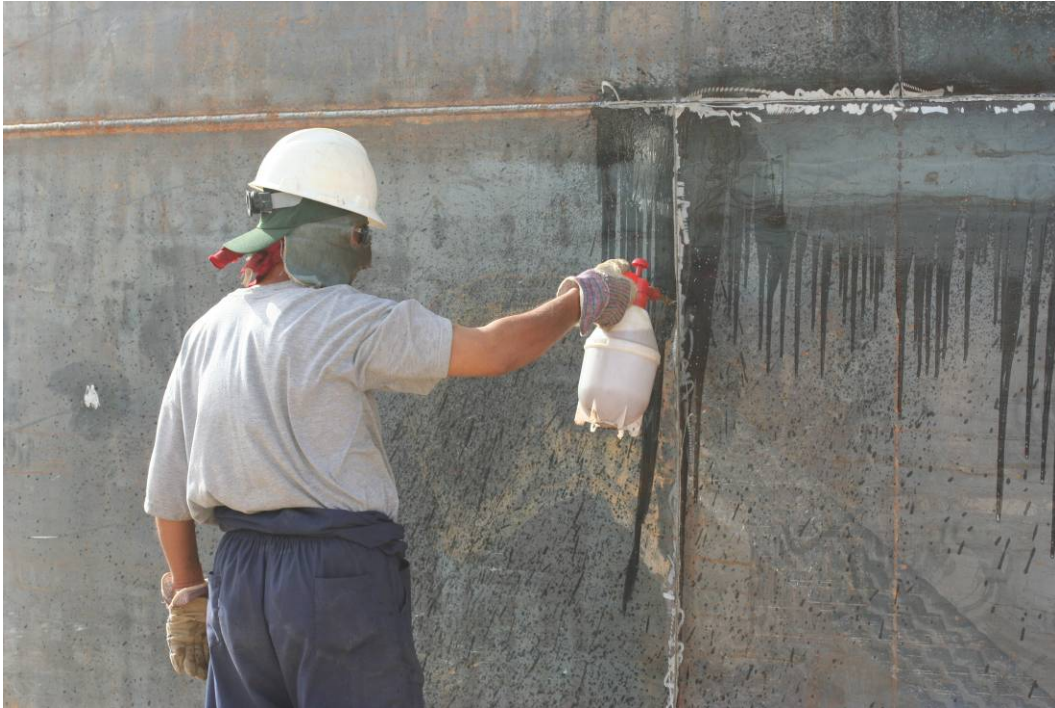
After grinding, a diesel penetrant test was performed on the exposed metal. However, procedures applicable in this sort of case required only an hour dwell time. Accordingly, diesel was sprayed on the outside of the tank and workers waited at least an hour to determine if the diesel penetrated the welds. If the diesel penetrated

the weld, the failed weld area was marked and subsequently rewelded and retested. Site Photo 22 illustrates how workers applied/sprayed the light diesel penetrant to a welded seam.

Site Photo 22. Diesel was sprayed on horizontal and vertical welds to conduct a penetrant test.

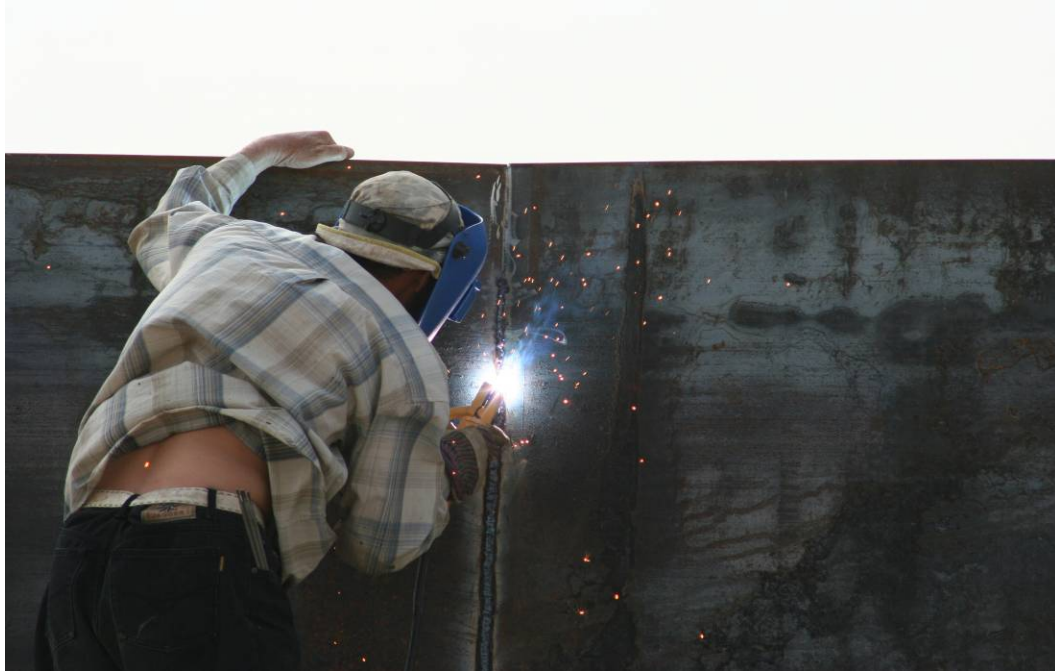
The second run welds were applied after outer shell plate welds passed the penetrant test. To complete the outer shell plate weld, the second run weld was applied along the bead where the weld was ground flush. In Site Photo 23, a worker completed the second run vertical welds on the outside of the shell plate. Site Photo 24 shows a completed second run vertical weld. The final, or third set of runs, was completed on the inside of the tank after all testing and retesting was successfully completed.

Site Photo 23. Worker completes second run vertical weld on a shell plate.

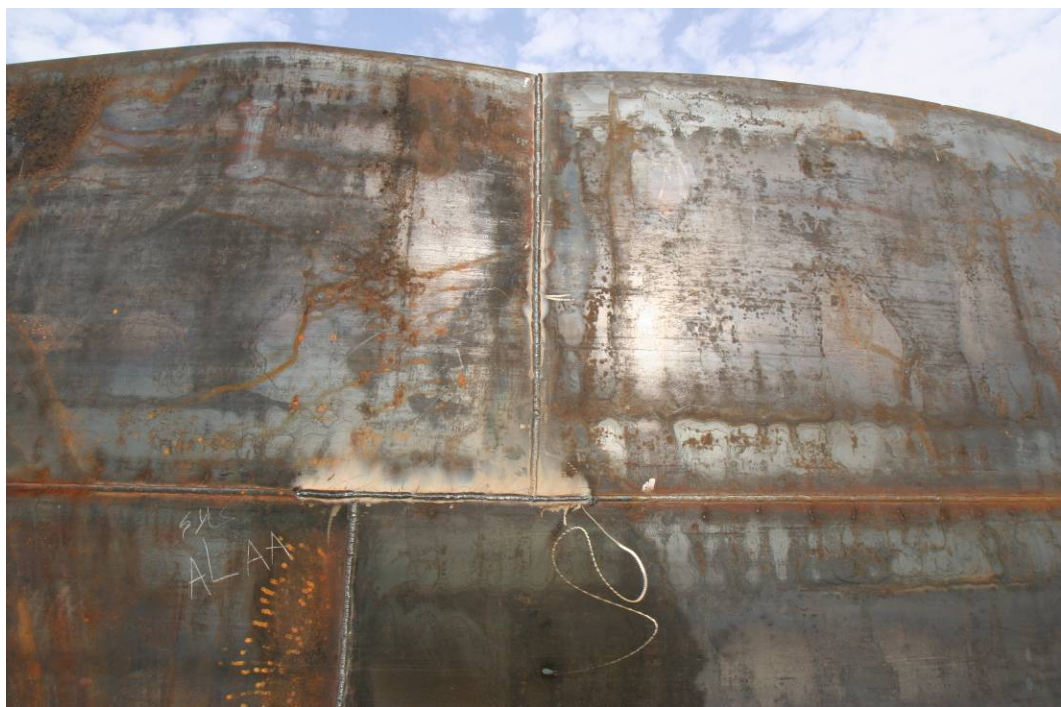
Site Photo 24. Completed second run on a vertical weld of a shell plate.
